## **Reference 13**

**Falcon Refinery  
TXD 086 278 058**

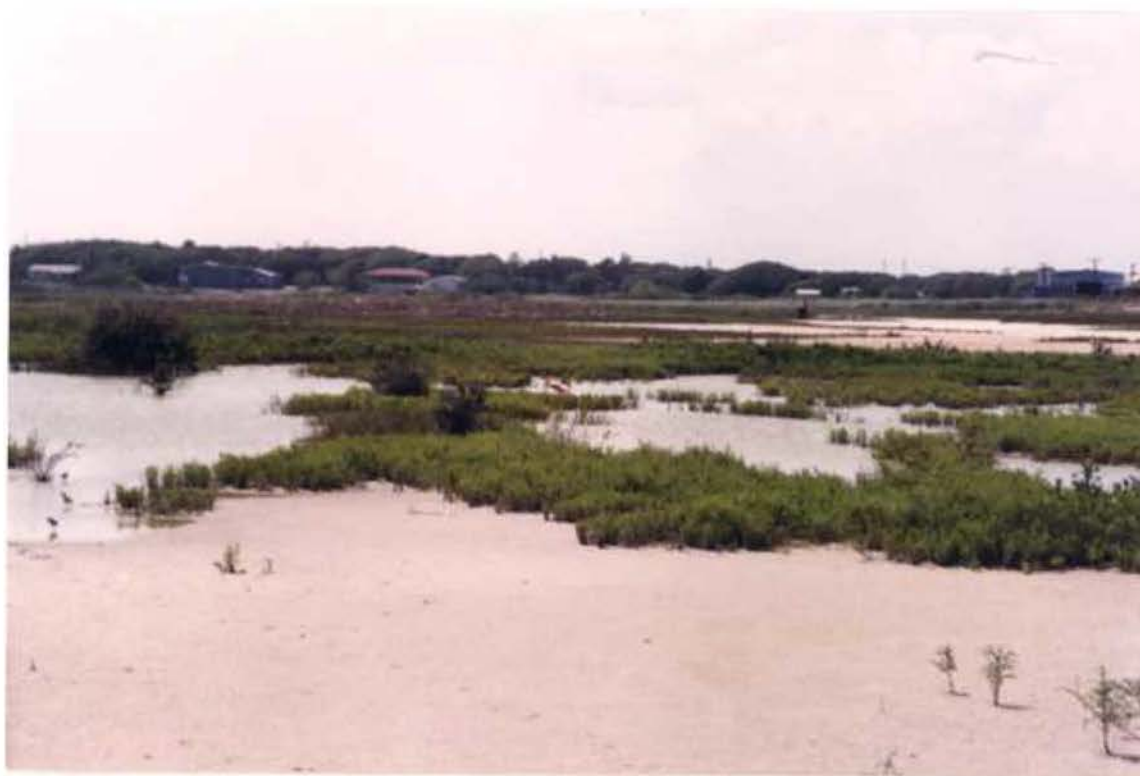
Roll #1 Photo 2 - 5/15/2000 Taken by: W. Newberry. Roseate Spoonbill. Direction: North.

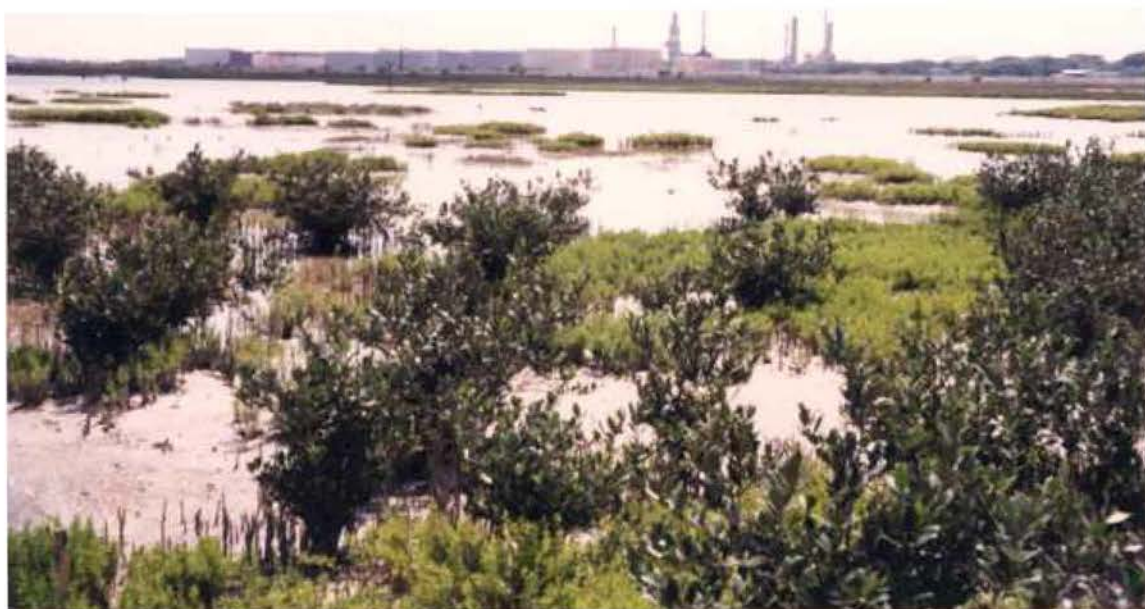
Roll #1 Photo 3 - 5/15/2000 Taken by: W. Newberry. Sampler: M.Cedilote. Collection of Sample SE-11 in wetland area near Alamo Concrete Products LTD. Direction: North.

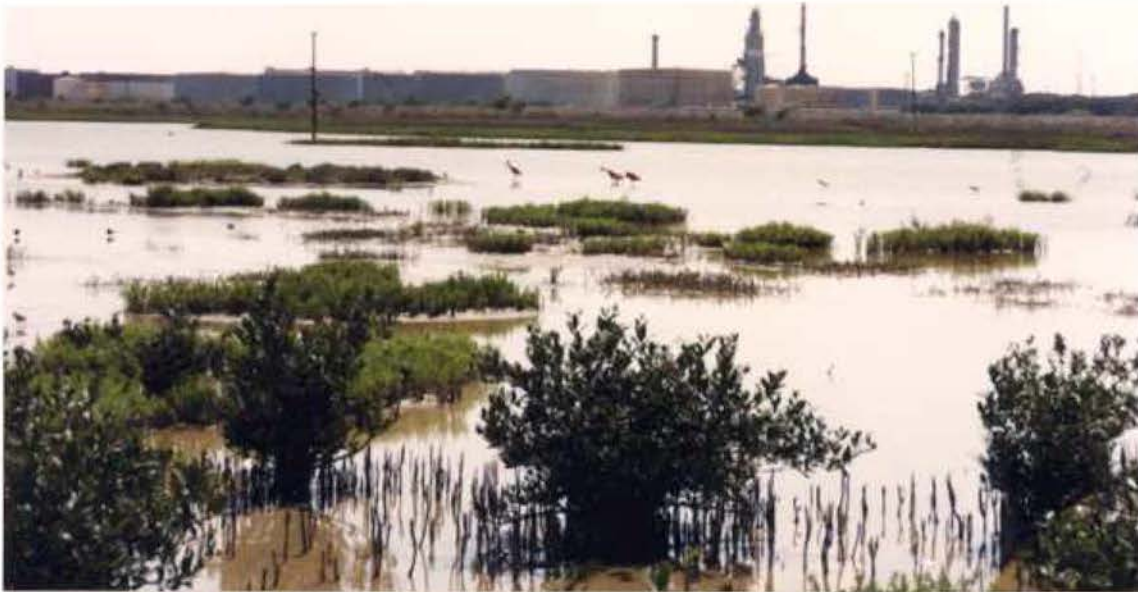
Roll #1 Photo 4 - 5/15/2000 Taken by: W. Newberry. Wetland area. Direction: West.

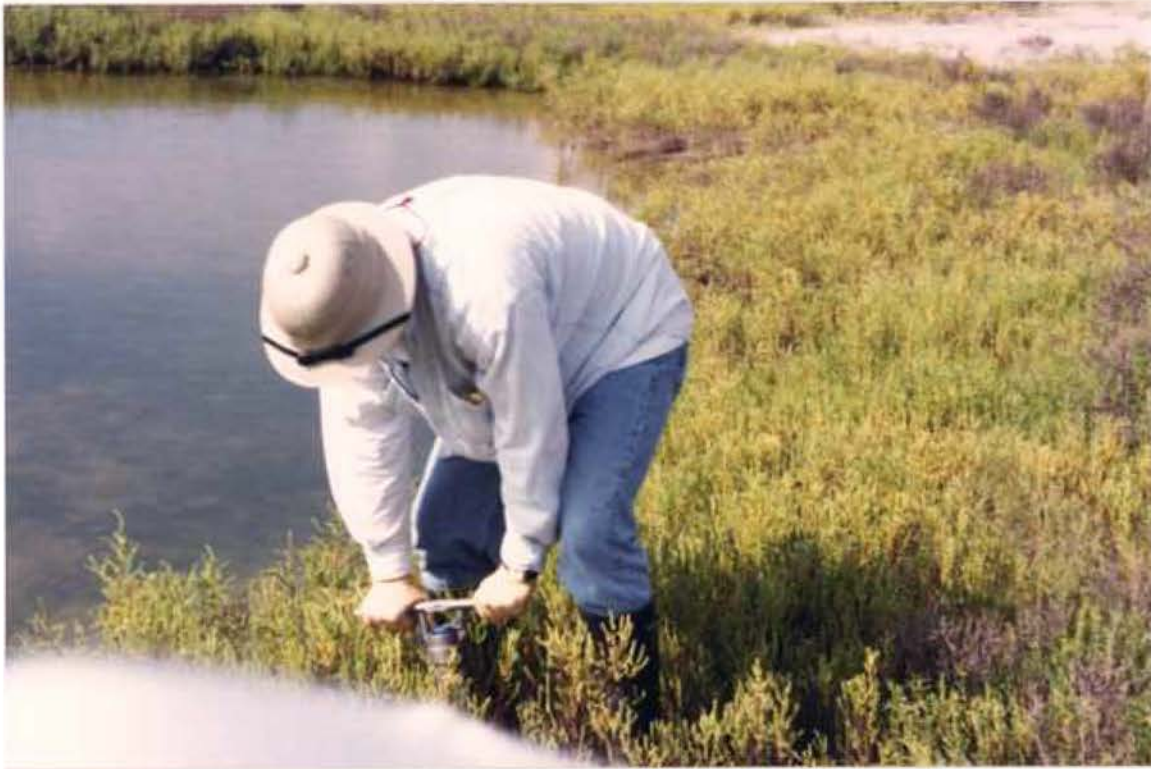
Roll #1 Photo 6 - 5/15/2000 Taken by: M.Cordell. Sampler: M.Cedilote. Collection of Sample SE-07 in HRS defined wetland area off the road near Aker Gulf Marine. Direction: North.

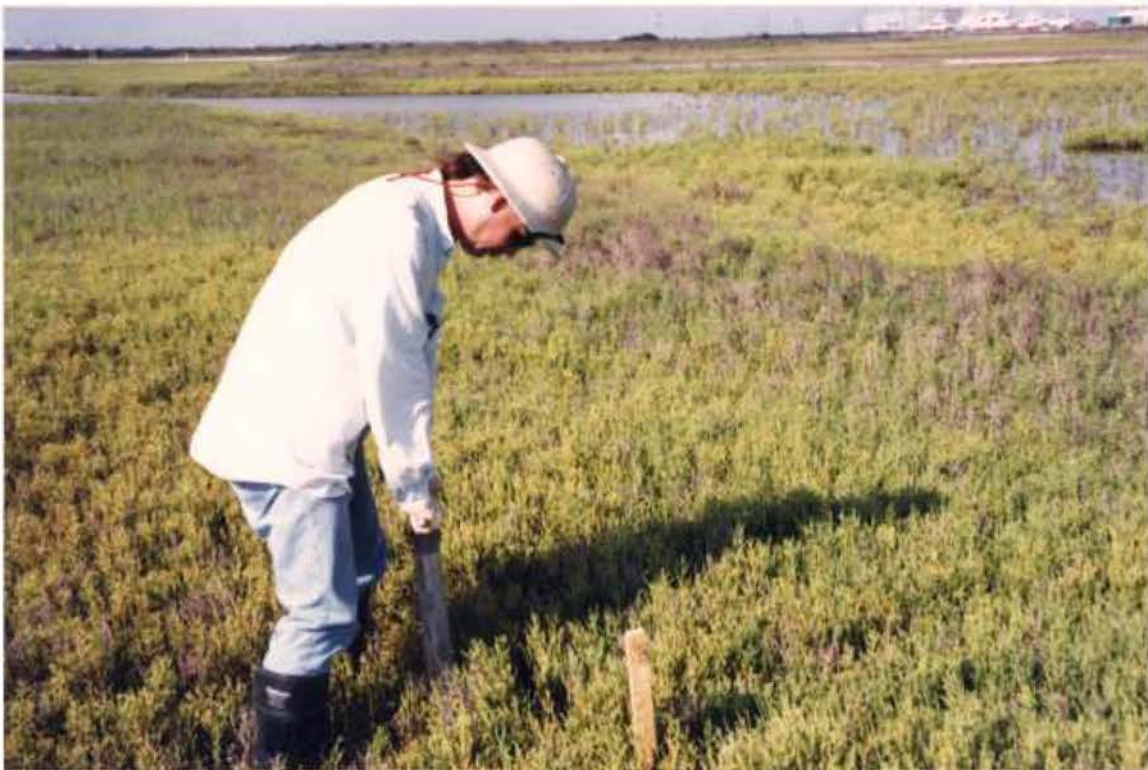
Roll #1 Photo 7 - 5/15/2000 Taken by: M.Cordell. Sampler: M.Cedilote. Collection of Sample SE-07 in HRS defined wetland area off the road north of Aker Gulf Marine. Direction: North.

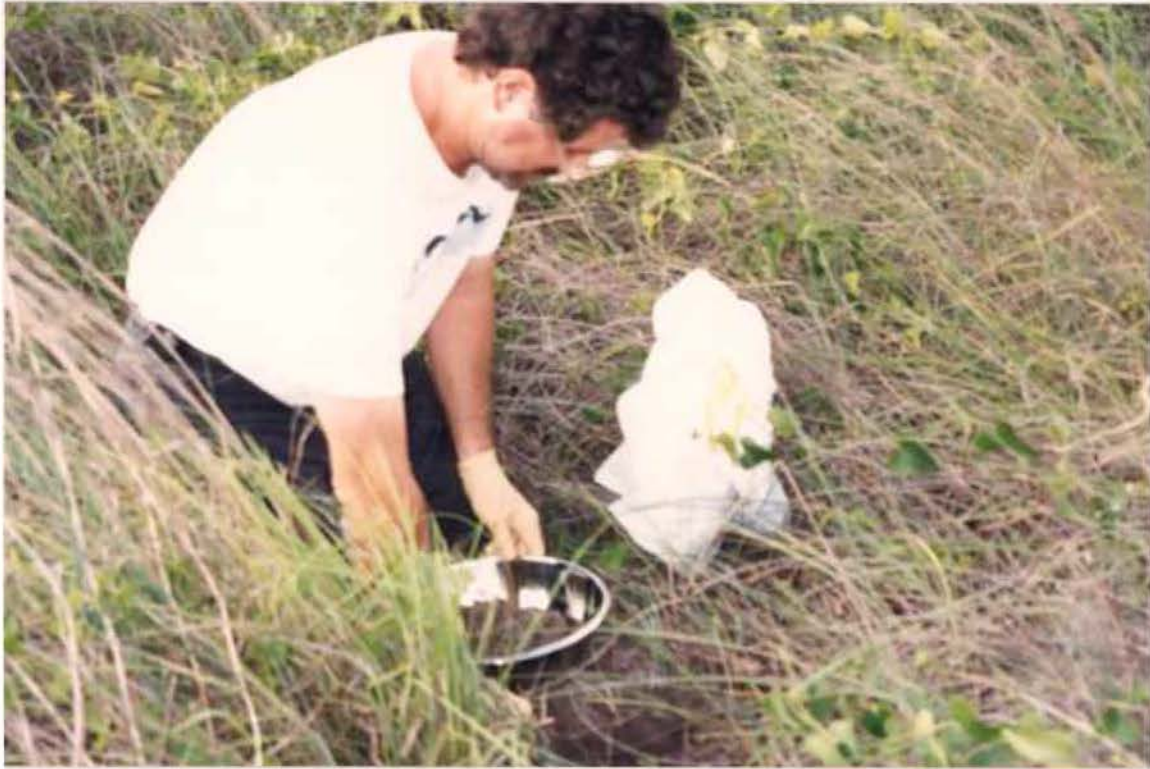
Roll #1 Photo 8 - 5/15/2000 Taken by: W. Newberry. Sampler: M.Cedilote. Collection of Sample SE-08 in HRS defined wetland area off the road north of Aker Gulf Marine. Direction: East.

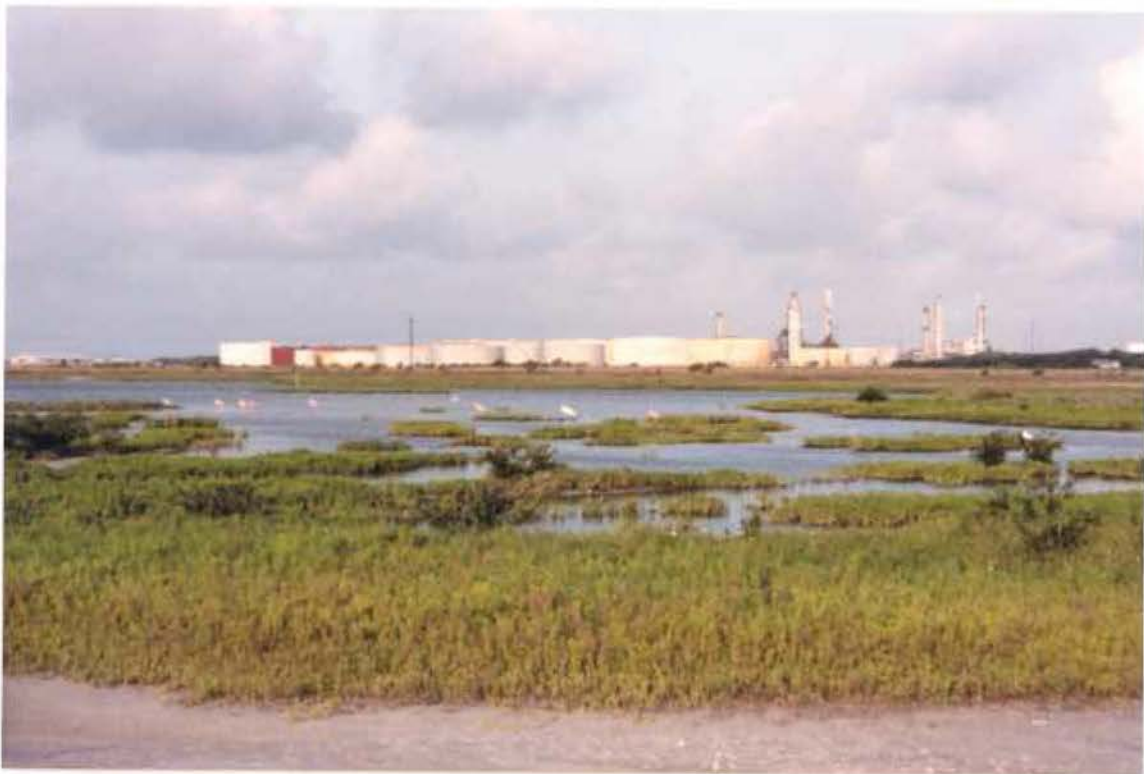
Roll #1 Photo 9 - 5/15/2000 Taken by: M. Cordell. Sampler: W. Newberry. Collection of Sample SO-01 at the north side of Sunray Road on the east side of FM 2725. Direction: North.

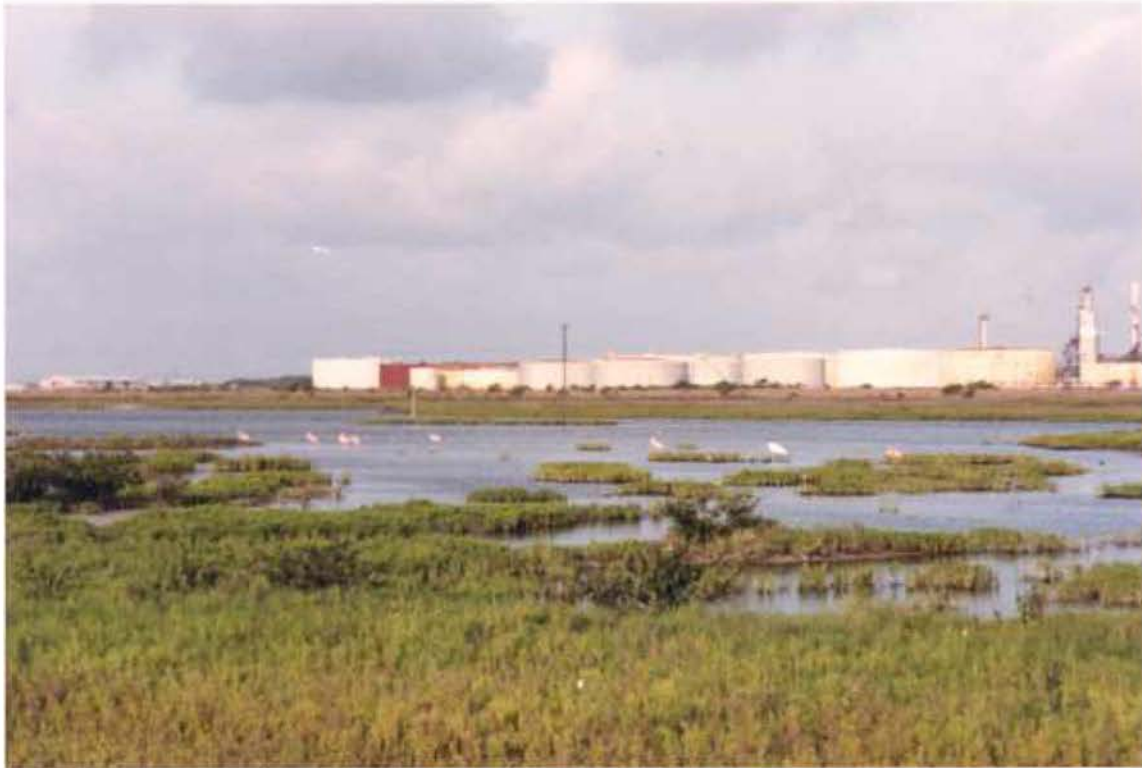
Roll #1 Photo 10 - 5/16/2000 Taken by: M.Cordell. Roseate Spoonbills. Direction: Southwest.

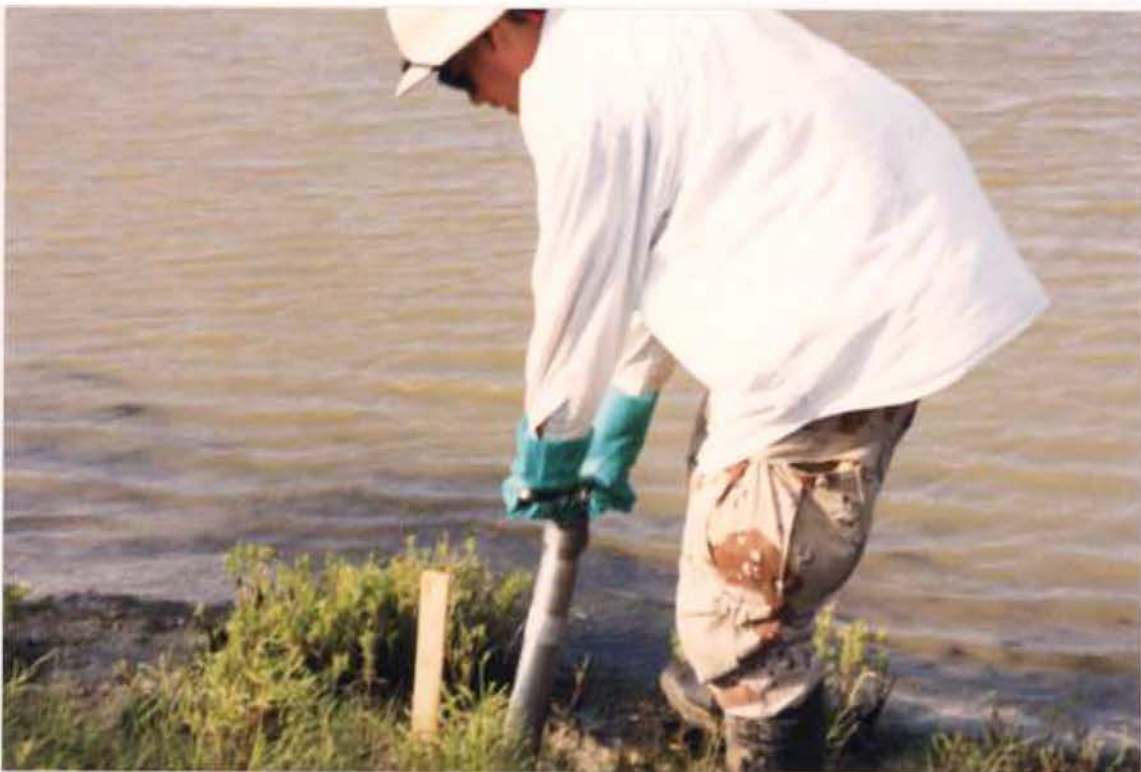
Roll #1 Photo 17 - 5/16/2000 Taken by: M.Cordell. Sampler: M.Cedilote. Collection of Sample SE-29; runoff from Aker Gulf Marine. Direction: Southeast.

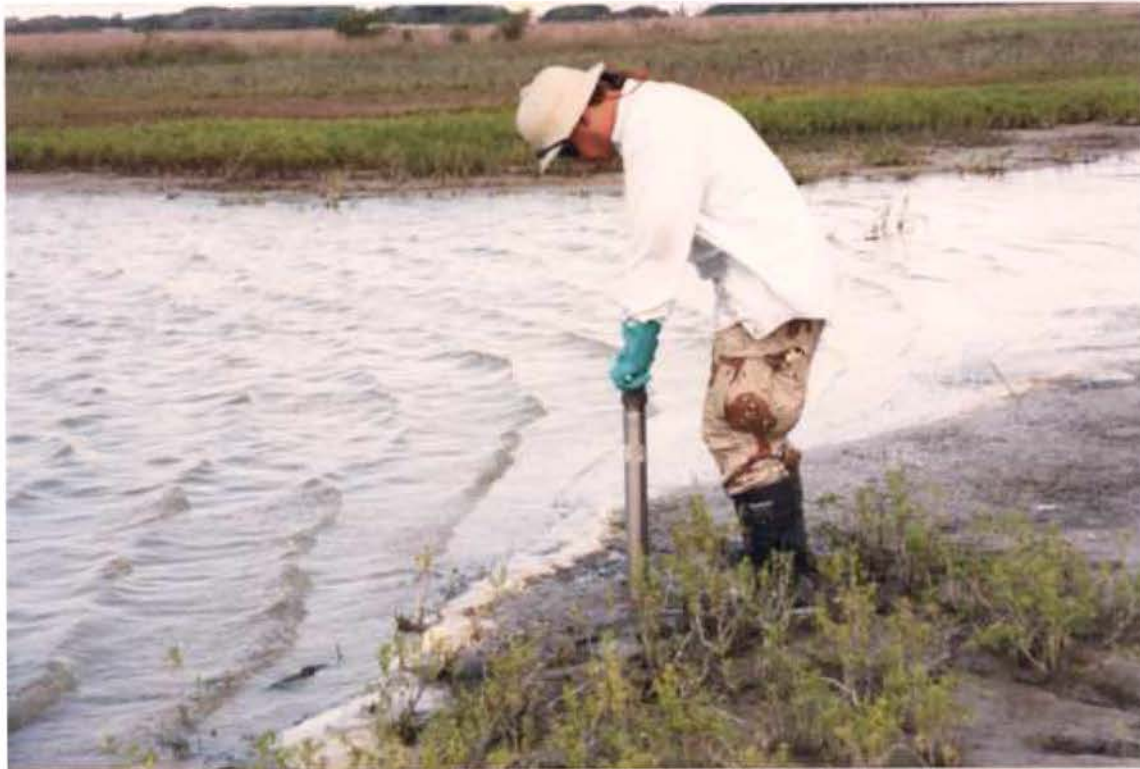
Roll #1 Photo 18 - 5/16/2000 Taken by: M.Cordell. Sampler: M.Cedilote. Collection of Sample SE-13 in HRS defined wetland area. Direction: South-southeast.

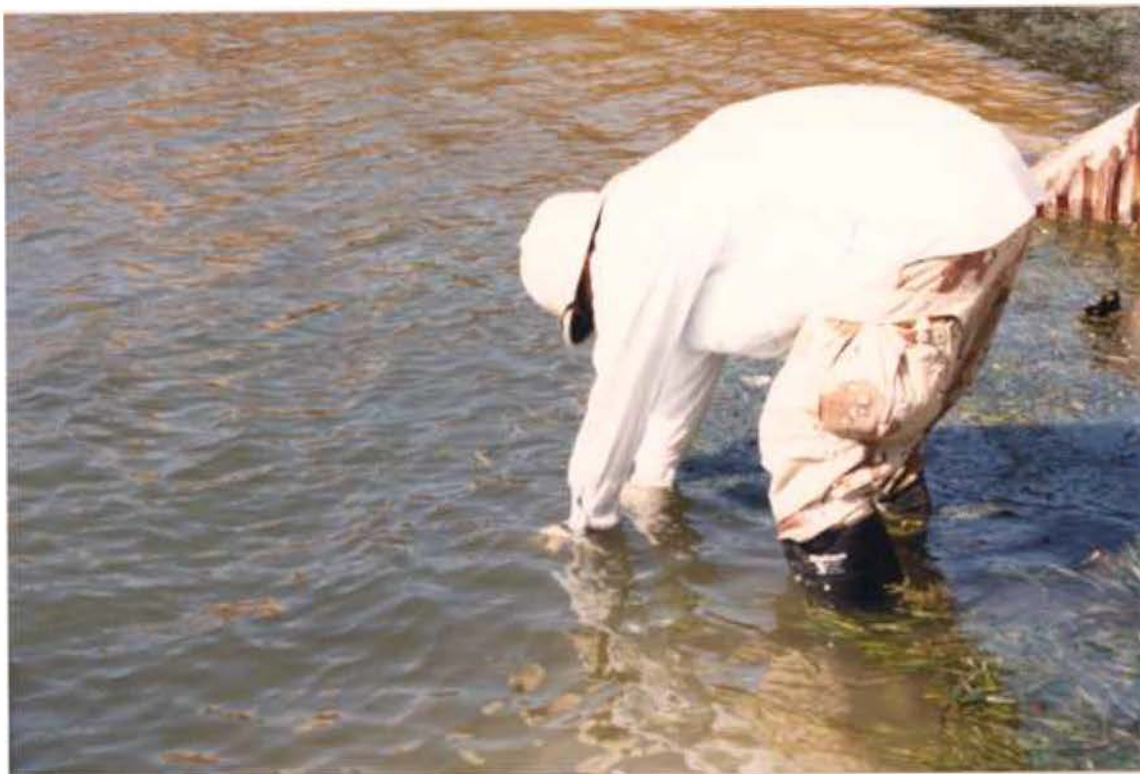
Roll #1 Photo 19 - 5/16/2000 Taken by: M.Cordell. Sampler: M.Cedilote. Collection of Sample SE-14 in HRS defined wetland area between Sunray Road and Aker Gulf Marine. Direction: Southwest.

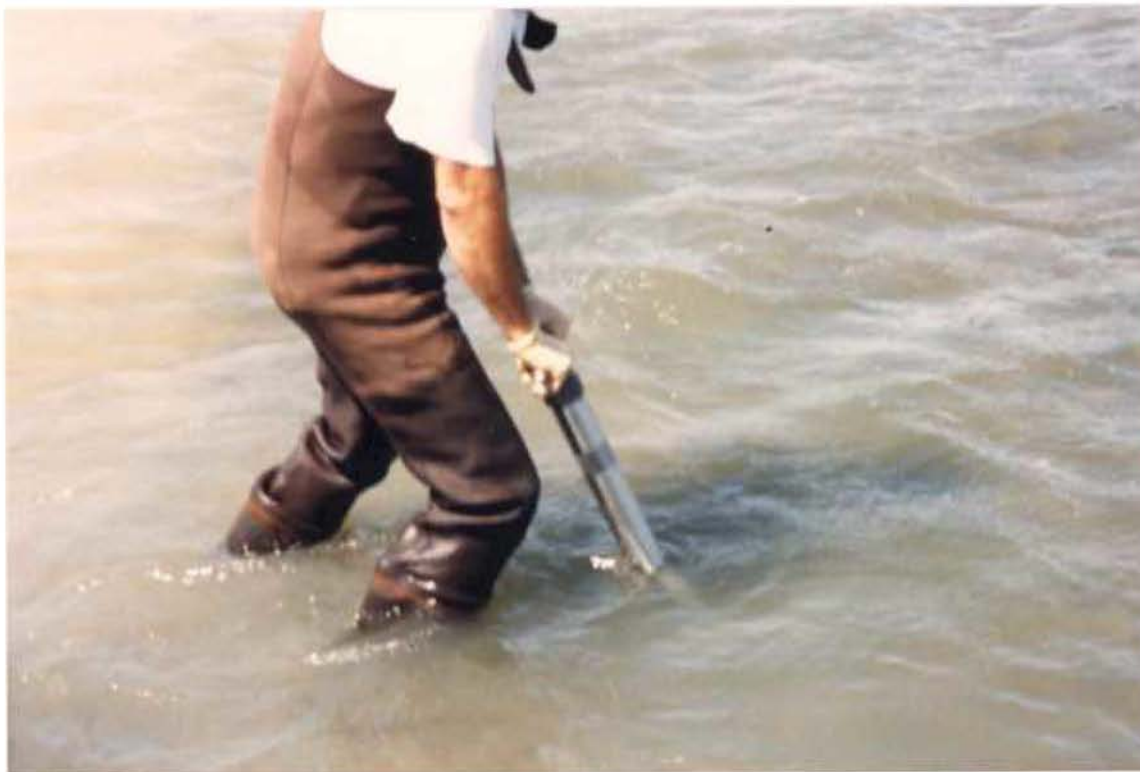
Roll #1 Photo 20 - 5/16/2000 Taken by: M.Cordell. Sampler: M.Cedilote. Collection of Sample SE-09 at Redfish Bay side of the culvert. Direction: Southwest.

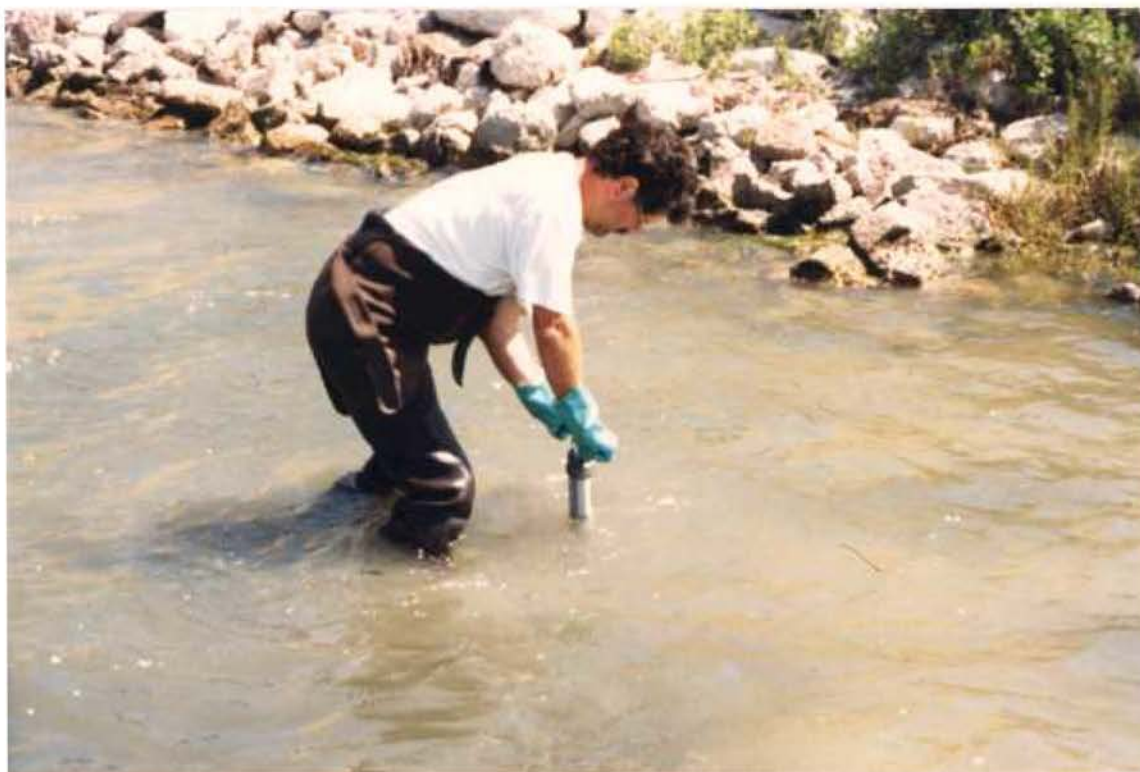
Roll #1 Photo 21 - 5/16/2000 Taken by: M. Cordell. Sampler: W. Newberry. Collection of Sample SE-31 in Redfish Bay. Direction: Northeast.

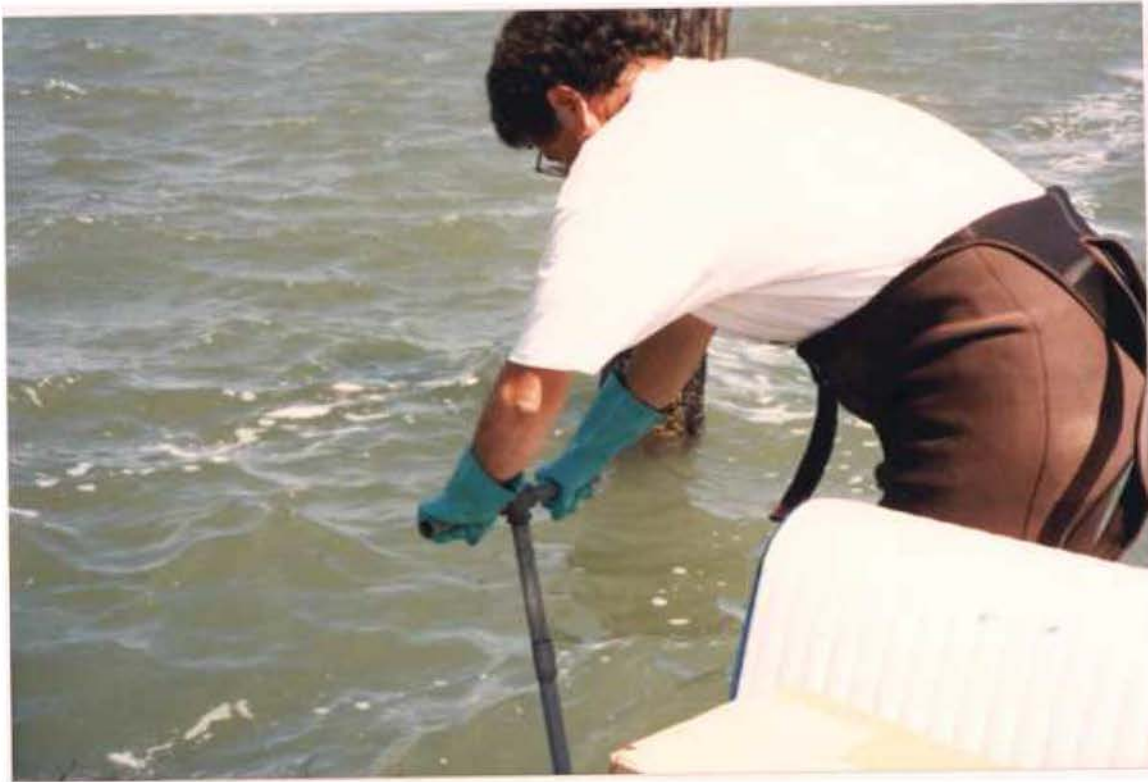
Roll #1 Photo 22 - 5/16/2000 Taken by: M. Cordell. Sampler: W. Newberry. Collection of Sample SE-01 in Redfish Bay at Brown & Root boat slip. Direction: Southwest.

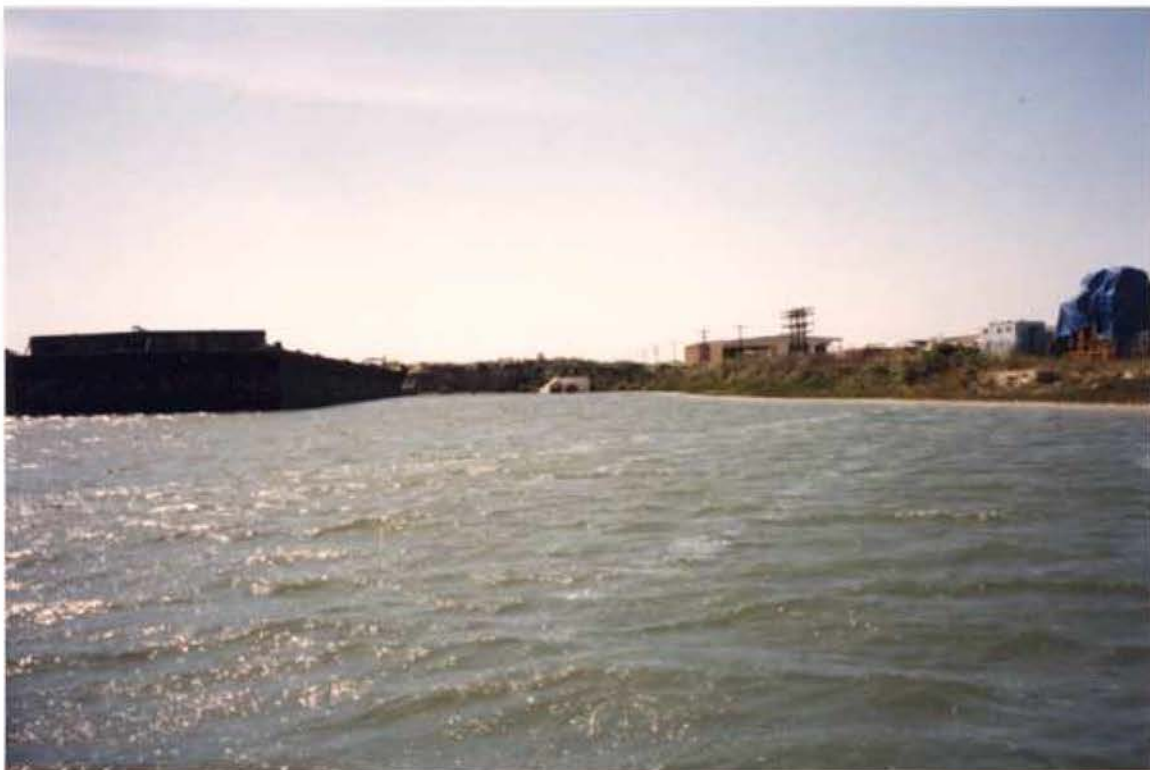
Roll #1 Photo 23 - 5/16/2000 Taken by: M. Cordell. Sampler: W. Newberry. Collection of Sample SE-30 in Redfish Bay at the MJP Resources/NORCO dock facility. Direction: Southwest.

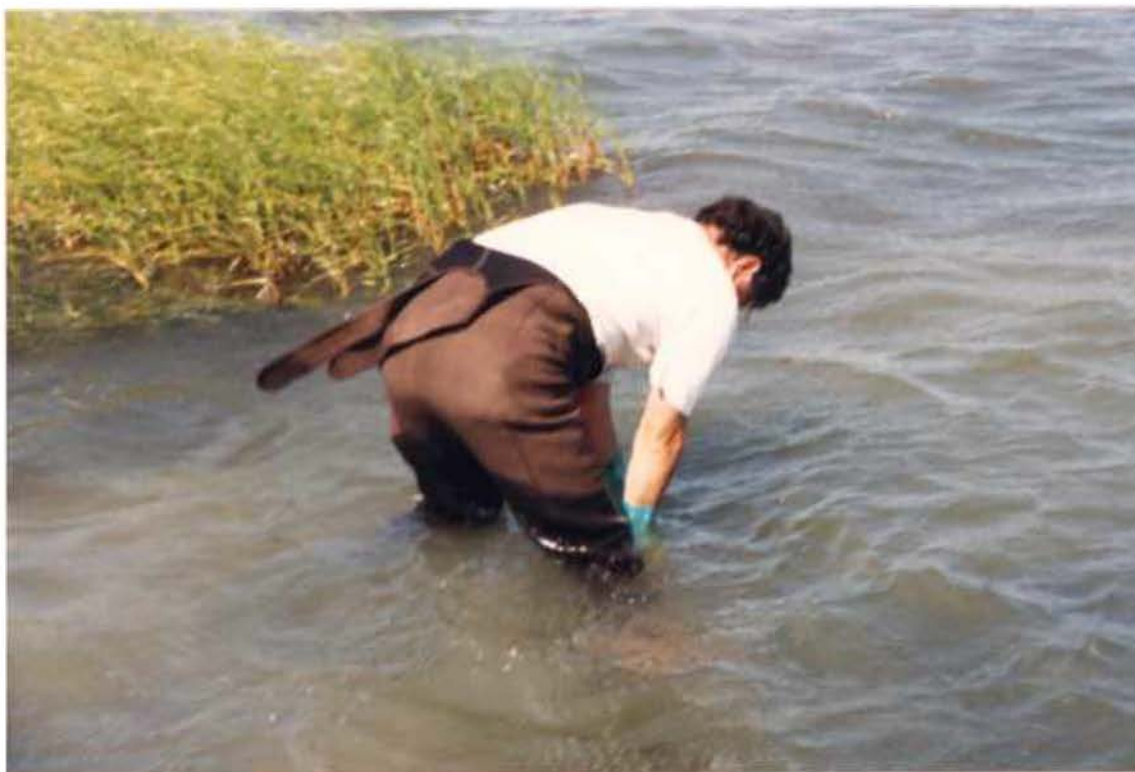
Roll #1 Photo 25 - 5/16/2000 Taken by: M.Cordell. Sampler: W. Newberry. Collection of Sample SE-03 in Redfish Bay. Direction: Northeast.

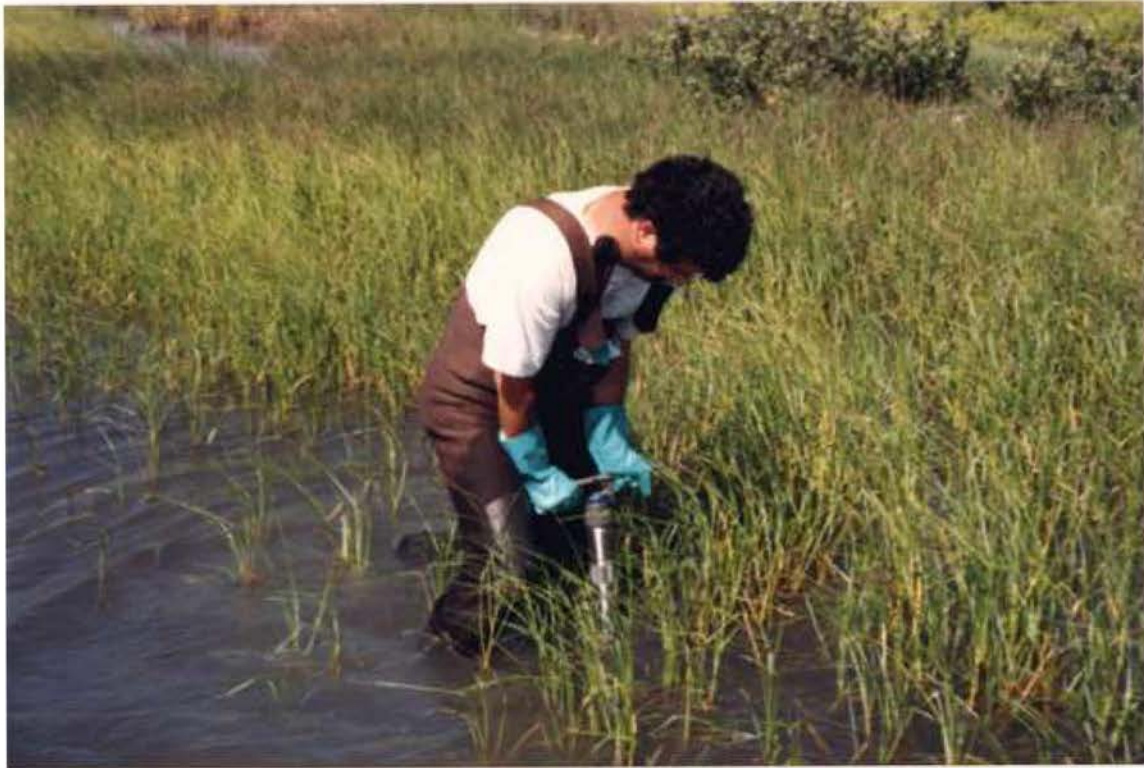
Roll #1 Photo 26 - 5/16/2000 Taken by: M.Cordell. Sampler: W. Newberry. Collection of Sample SE-06 in the Intracoastal Waterway north of Aker Gulf Marine. Direction: Northeast.

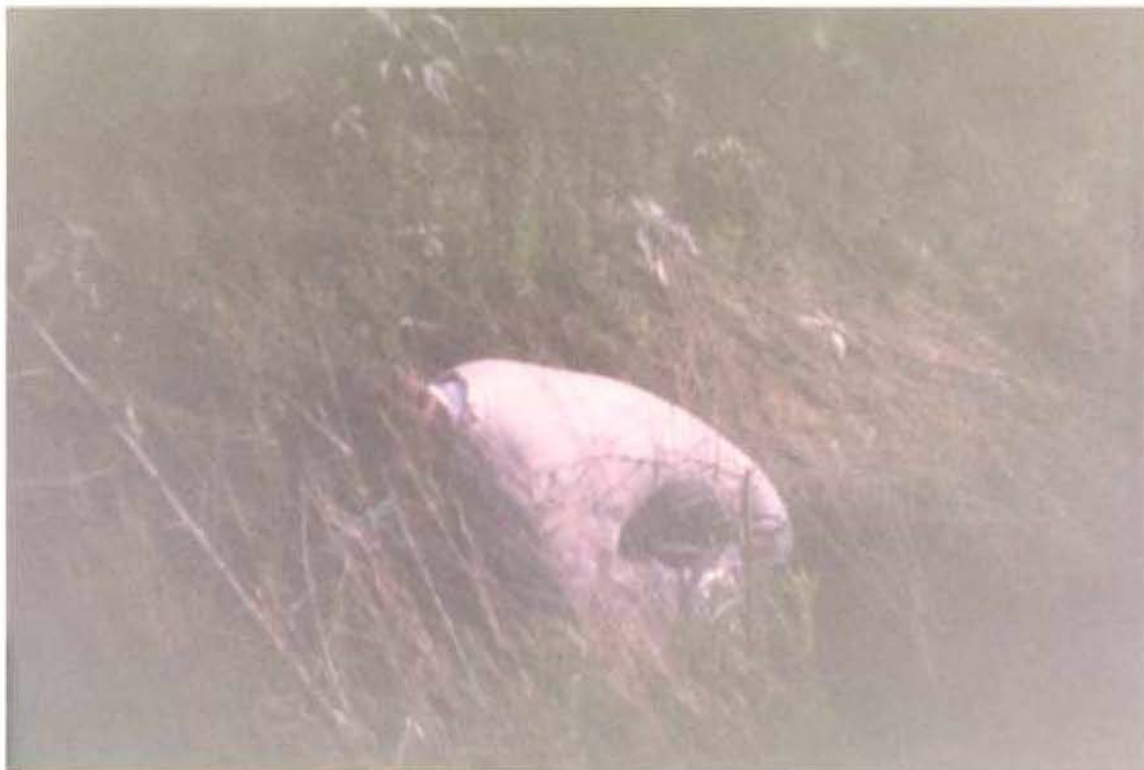
Roll #1 Photo 27 - 5/16/2000 Taken by: M.Cordell. Sampler: W. Newberry. Collection of Sample SE-05 in HRS defined wetlands across from culvert. Direction: Northwest.

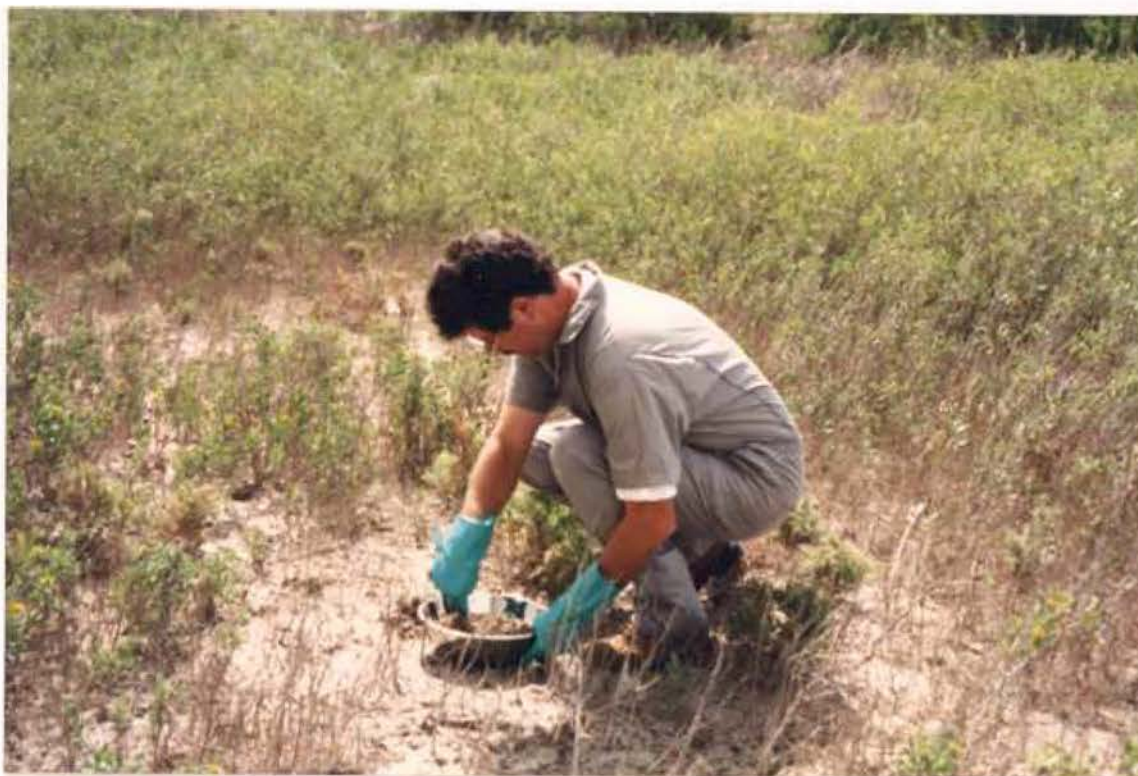
Roll #1 Photo 29 - 5/17/2000 Taken by: M.Cordell. Sampler: W. Newberry. Collection of Sample SO-22 near Tank 10. Direction: South.

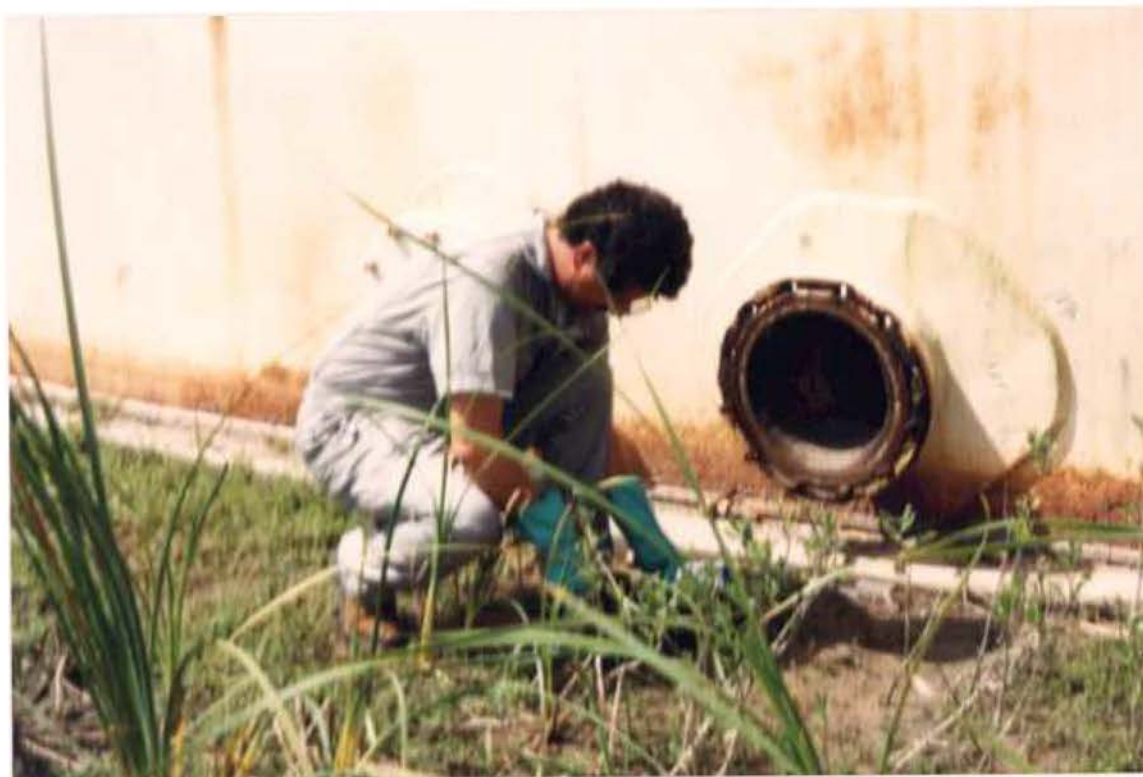
Roll #1 Photo 30 - 5/17/2000 Taken by: M.Cordell. Sampler: W. Newberry. Collection of Sample SO-18 near Tank 26. Direction: East.

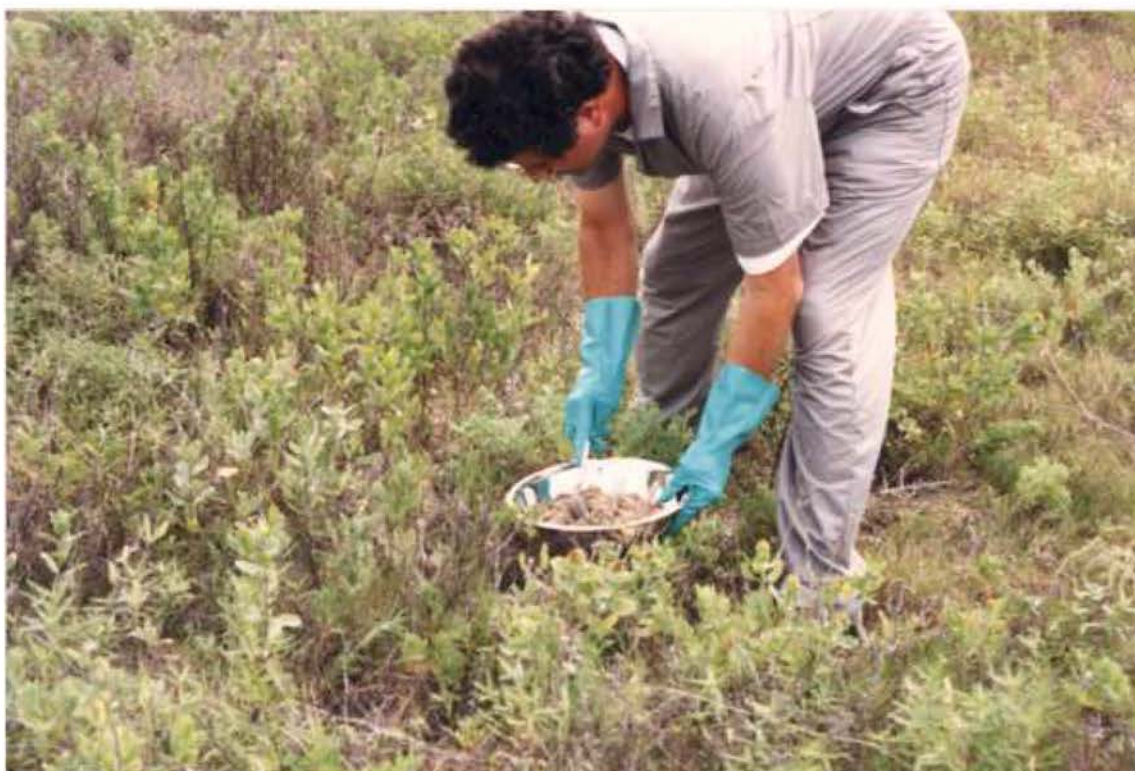
Roll #1 Photo 31 - 5/17/2000 Taken by: M.Cordell. Sampler: W. Newberry. Collection of Sample SO-16 near Tank 28. Direction: Southwest.

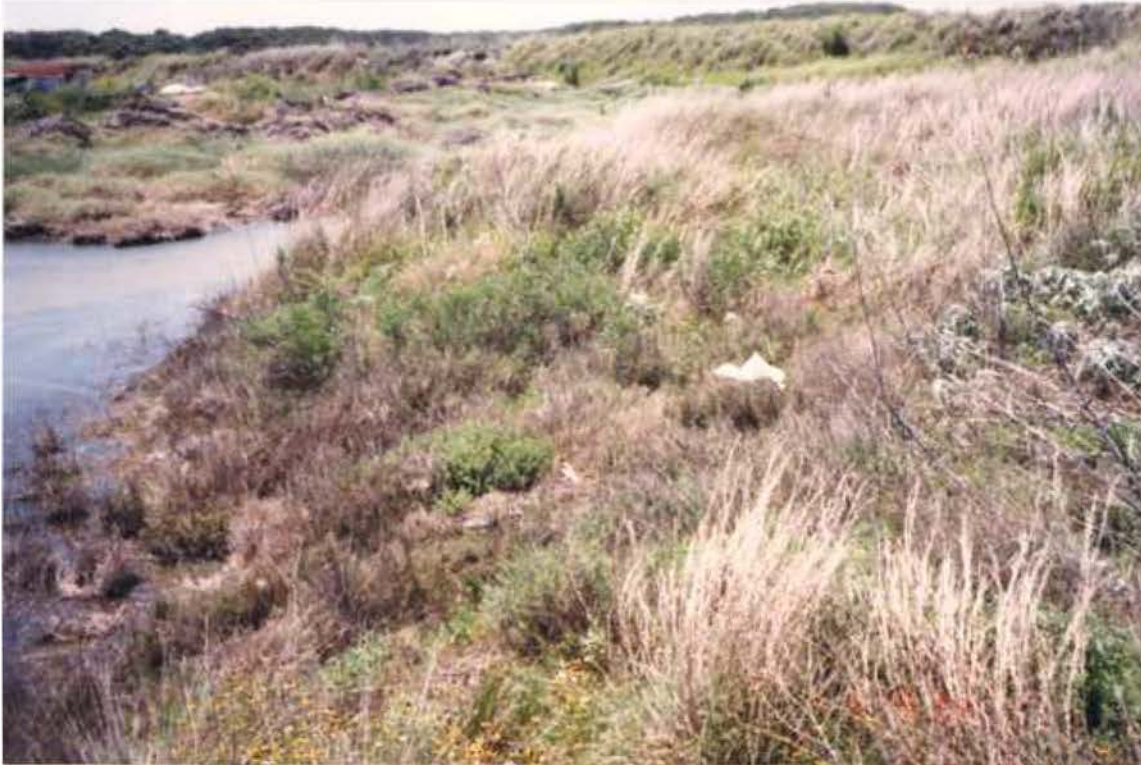
Roll #1 Photo 32 - 5/17/2000 Taken by: M.Cordell. Sampler: W. Newberry. Collection of Sample SO-24 near Tank 31. Direction: Northwest.

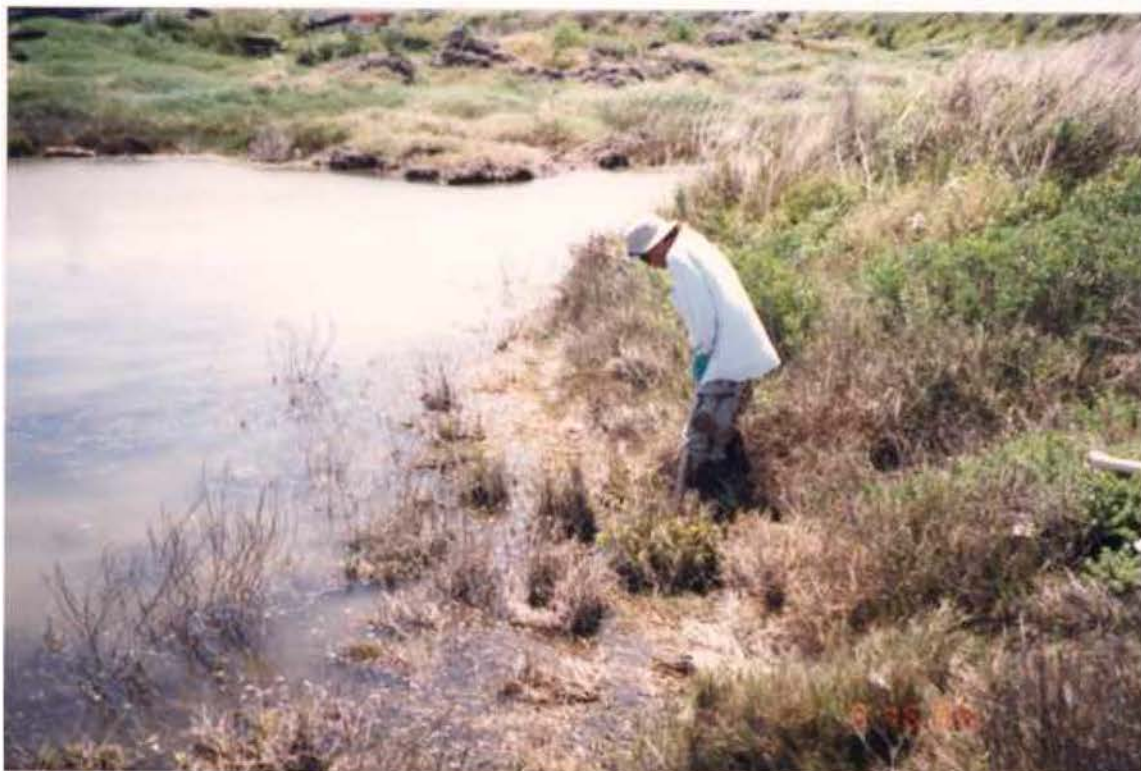
Roll #2 Photo 1 - 5/16/2000 Taken by: A. Seils. Sampler: M. Cedilote. Location of Sample SO-25 and SO-29 on Garrett Construction property. Direction: Northwest.

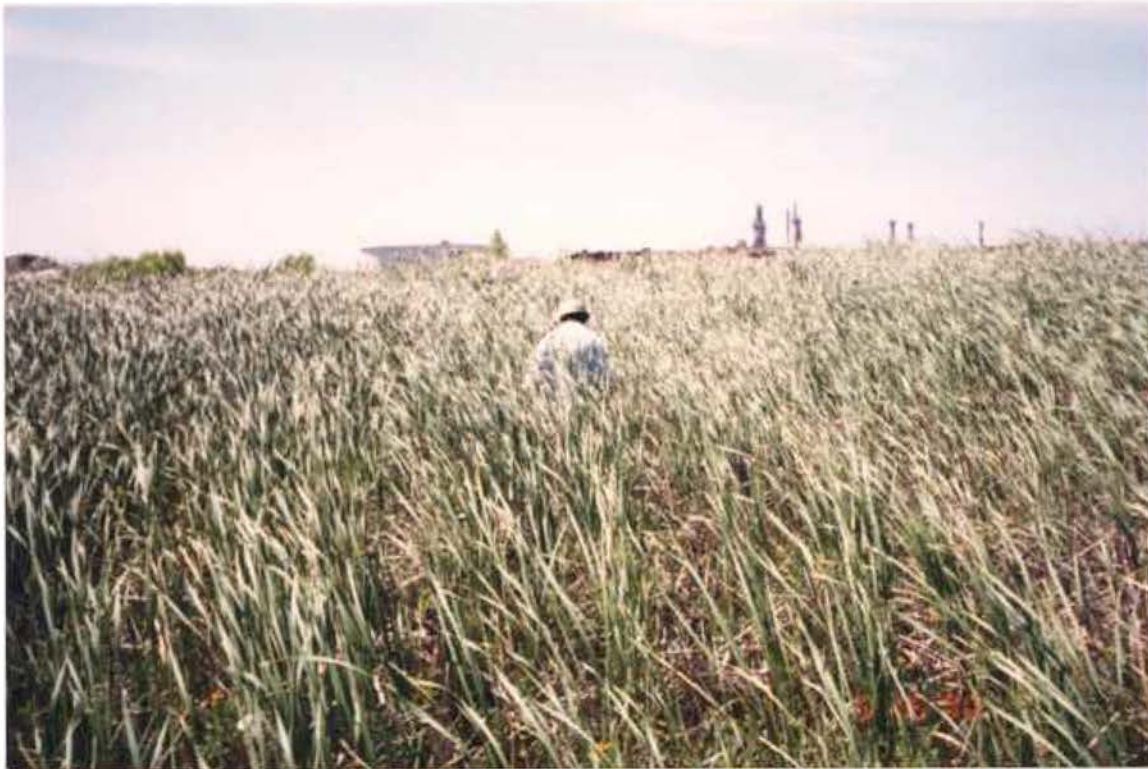
Roll #2 Photo 2 - 5/16/2000 Taken by: A. Seils. Sampler: M. Cedilote. Collection of Sample SE-25 on Garrett Construction property. Direction: Northwest.

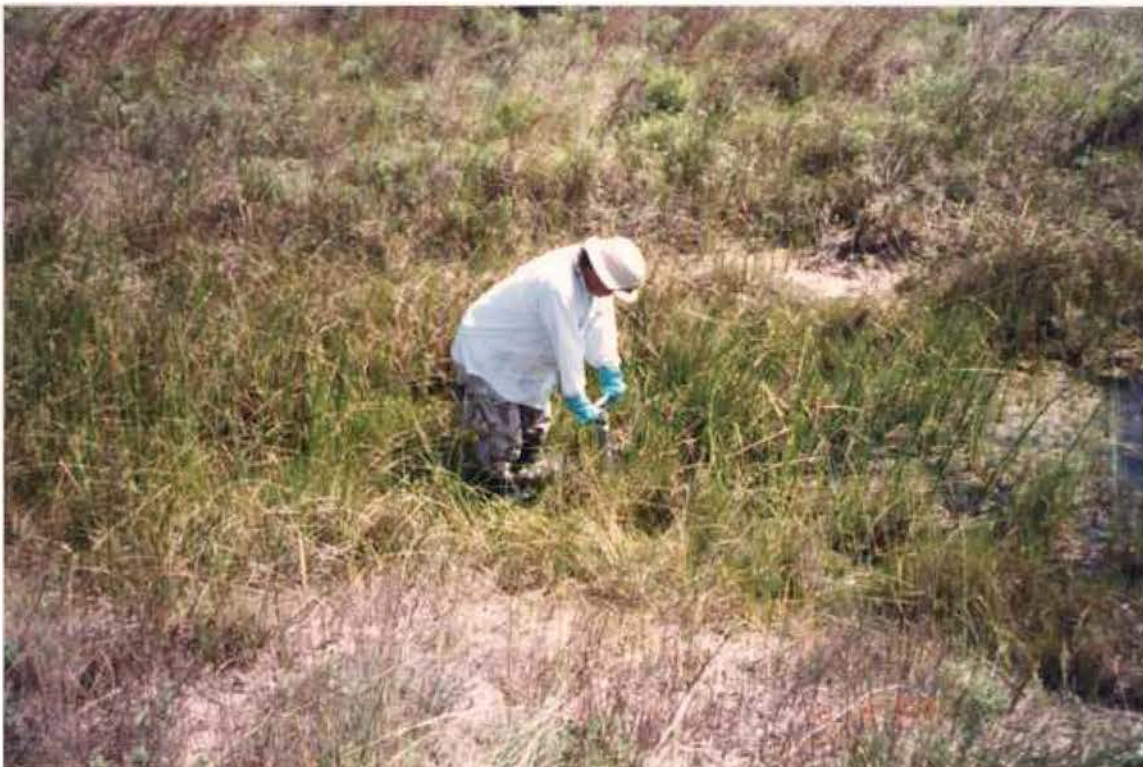
**Roll #2 Photo 3 - 5/16/2000 Taken by: A. Seils. Sampler: M. Cedilote. Collection of Sample SE-27. Direction: Northwest.**
